MISCELLANEOUS PAPER S-76-24

USAGE OF LANDING MAT AS OVERLAY ON ASPHALT RUNWAY DURING MILITARY FIELD EXERCISES

Hugh L. Green

December 1976

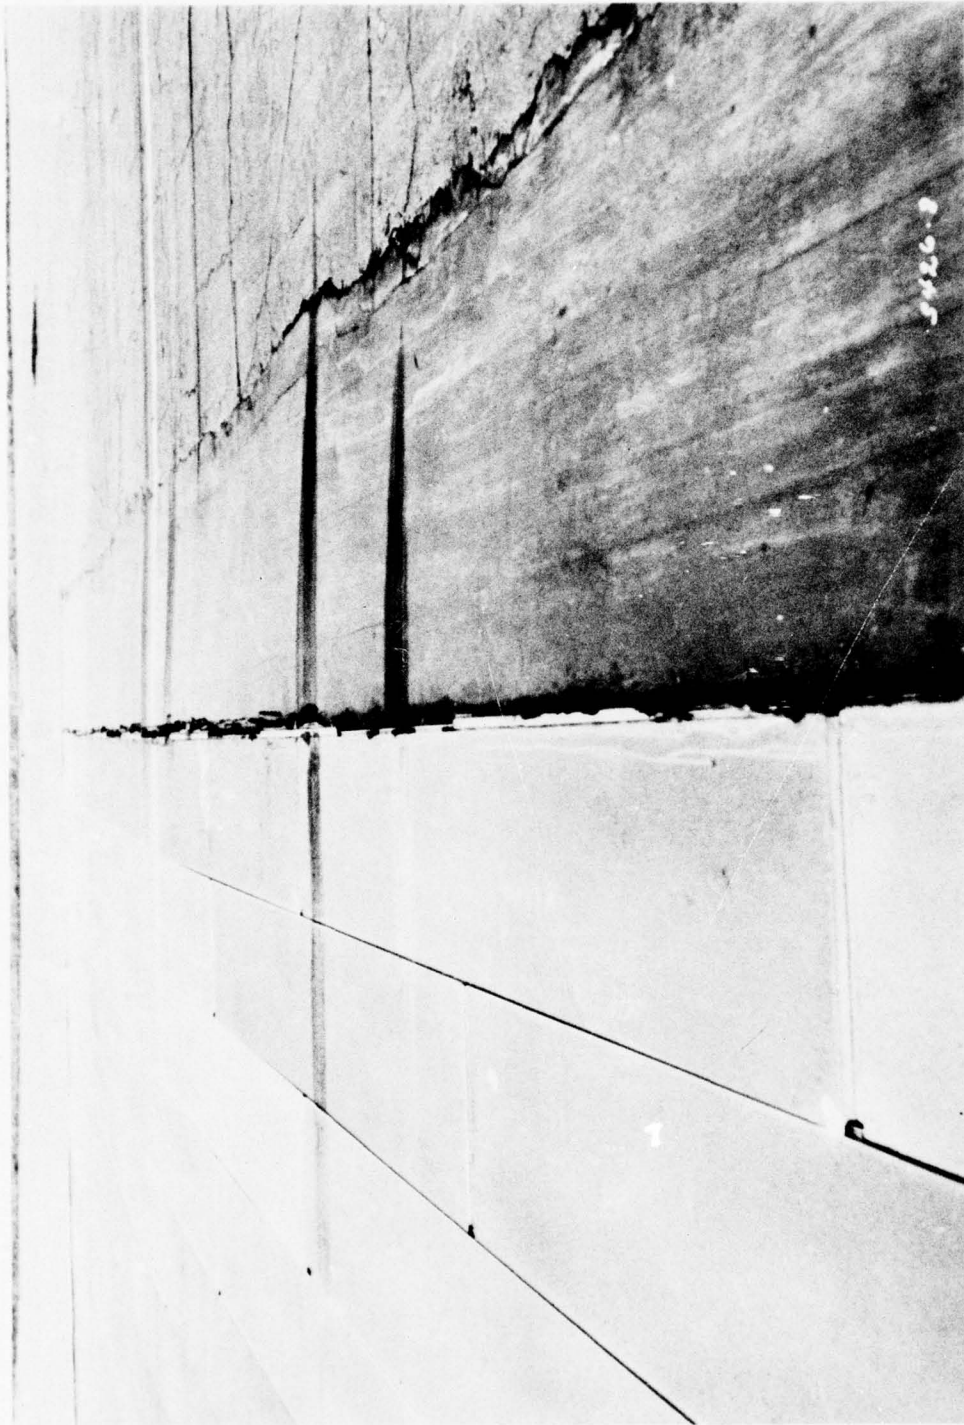
North end of landing mat runway showing transition between mat and asphalt. Aircraft skid marks are visible showing premature touchdown

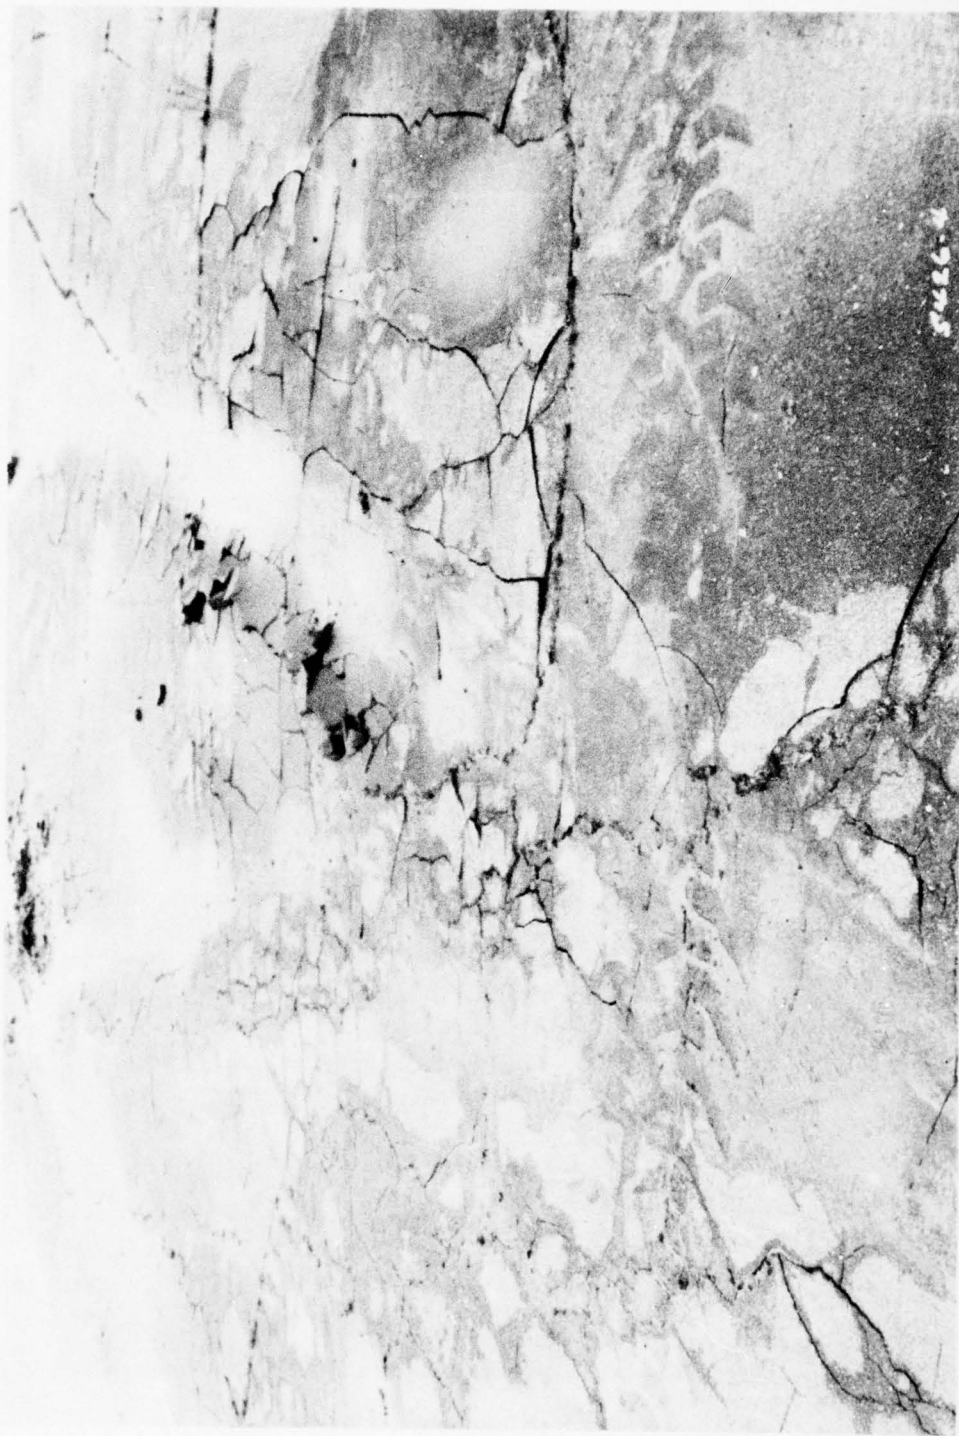
Rutted and broken asphalt in overrun area on south end of runway 18-36

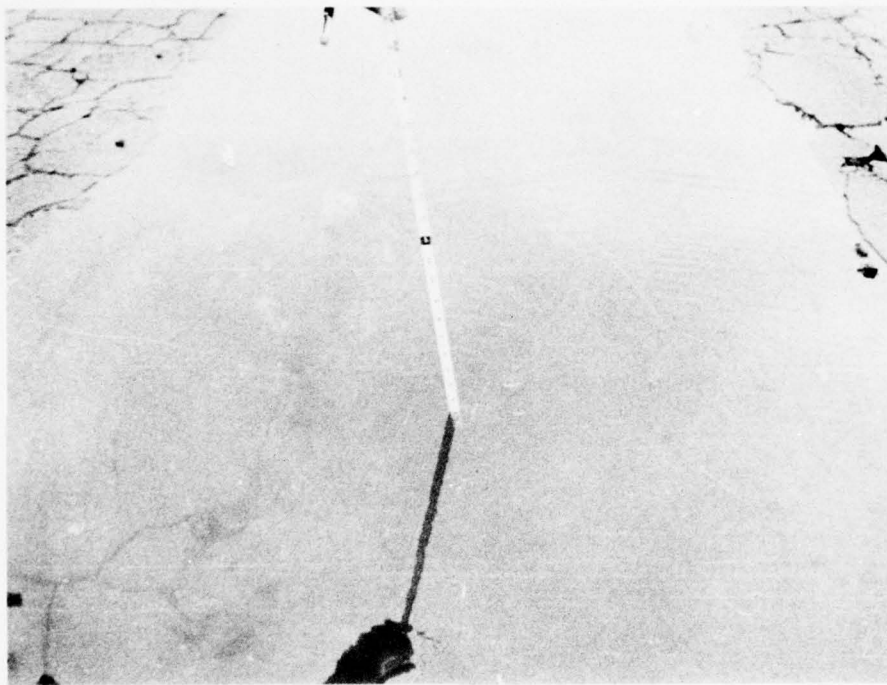
Water ponding in "birdbath" on runway 27-90

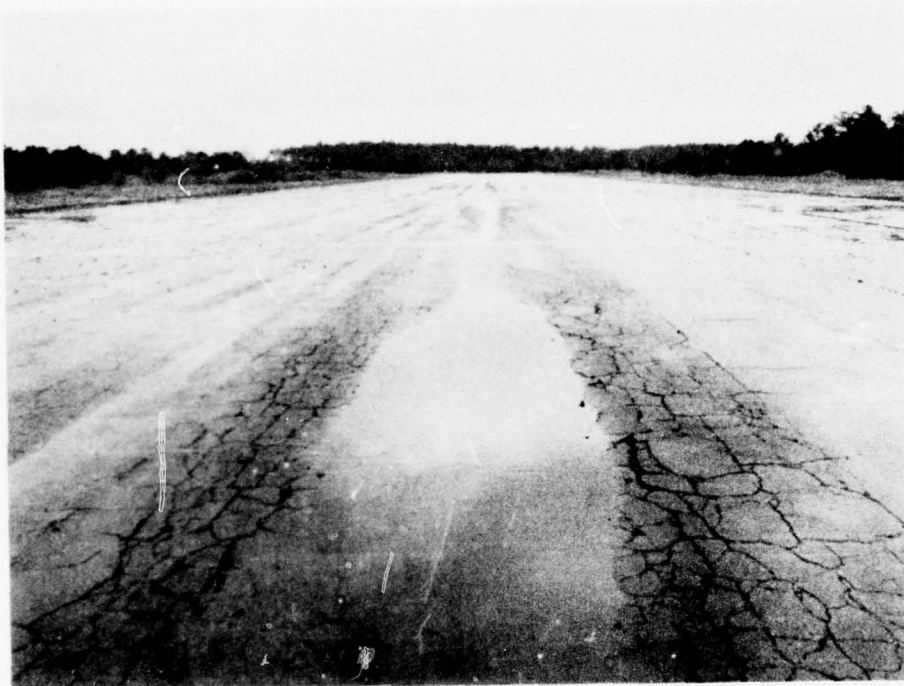
Incl 11

Deteriorating asphalt on runway 27-90

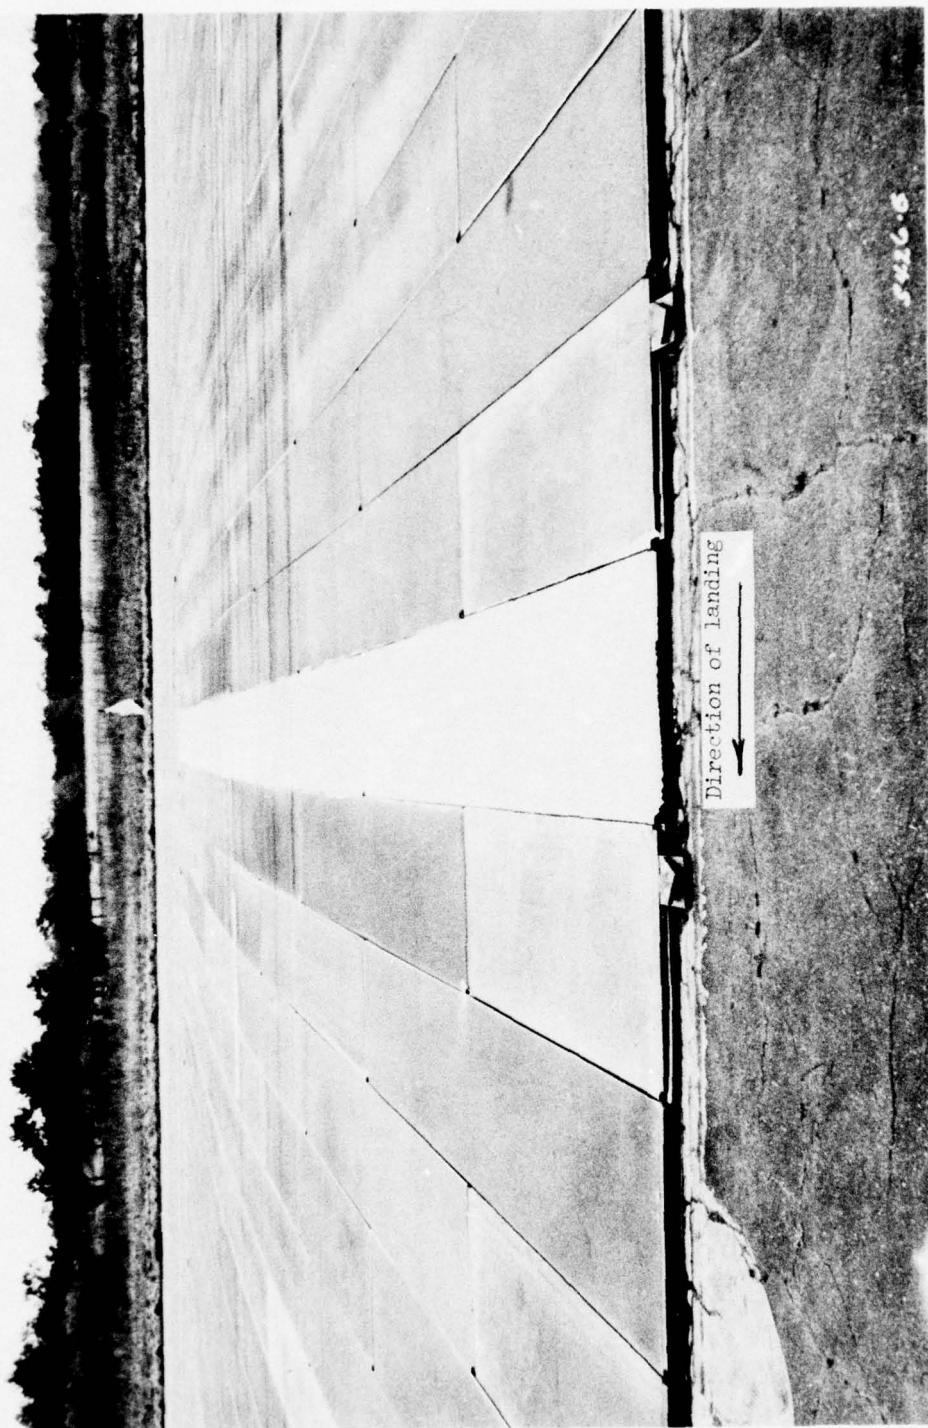
Bow line visible at sta 5+00

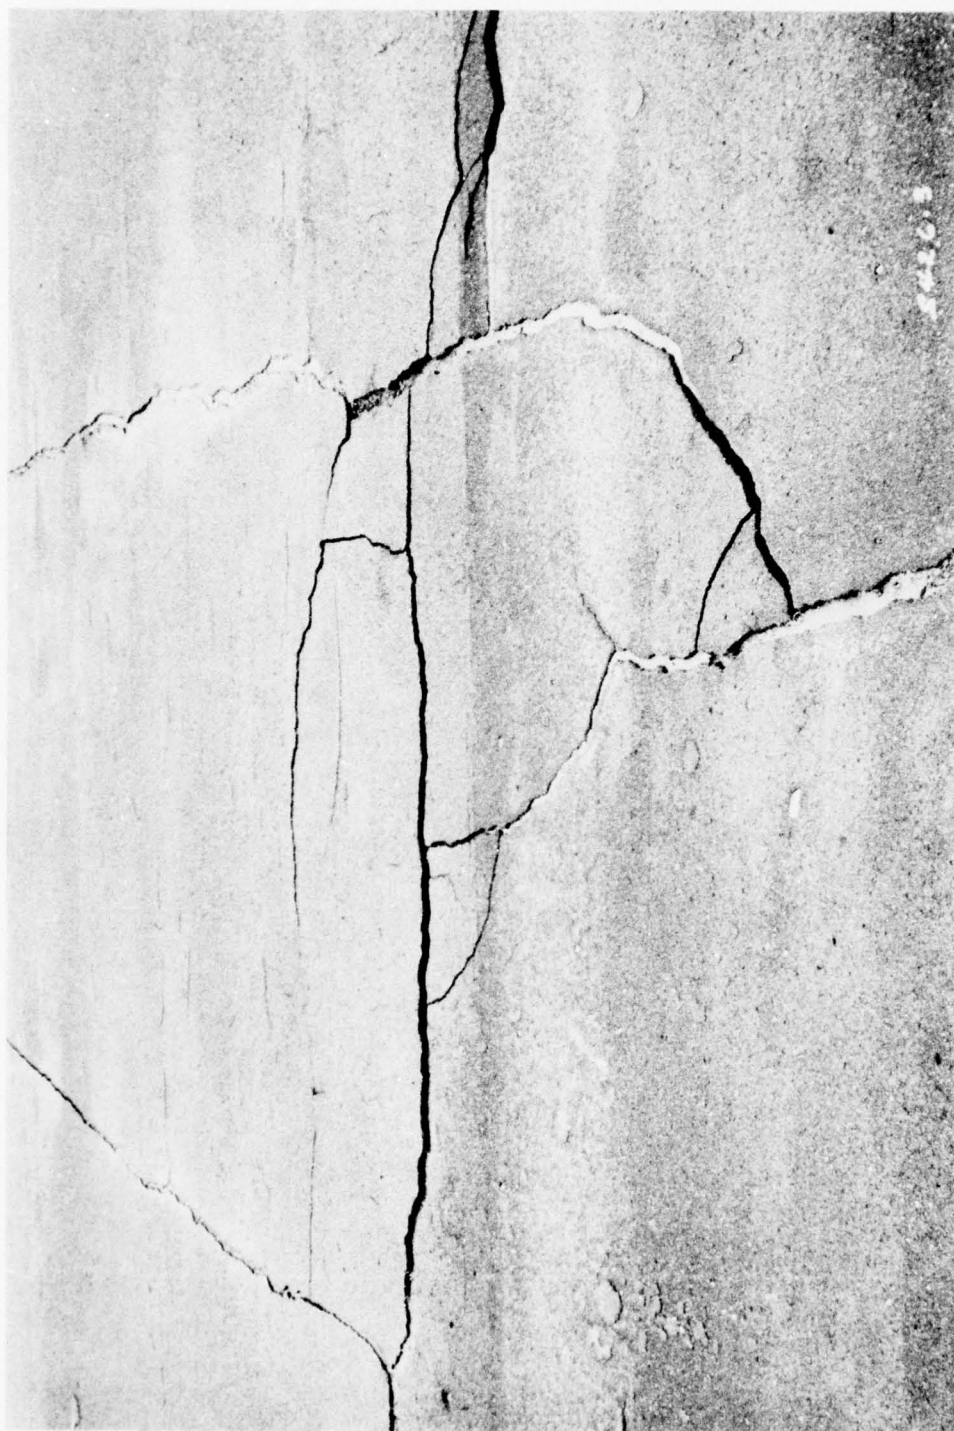
Incl 17

Rutting of asphalt occurring in taxiway

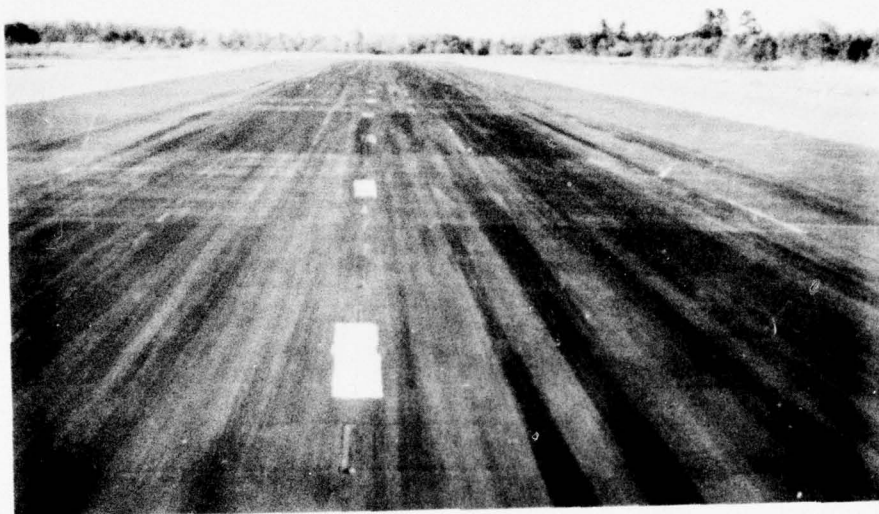
area prior to takeoff, thus creating three movements on the runway per sortie. Inclosure 18 shows skid marks on the mat runway in the touch-down area indicating the intensity of landings occurring in this area. Heavy rainfall caused some pumping of the sand blanket beneath the matting placed over the drainage culverts on runway 05-23. To correct this situation, the matting was removed, sand redistributed, and mat replaced and lengthened to cover an area 60 ft wide and 146 ft long. No failures were present, although the pad surface became somewhat wavy. This situation probably could have been eliminated by use of membrane beneath the mat or by use of a clay soil blanket underlay; however, only native sand was available in this vicinity as borrow material. The mat movement along the runway edges resulted in slightly irregular edges and caused the anchors to initially bind at panel joints and then to be pulled up slightly as movement continued. To alleviate a possible bow-wave condition and prevent anchors from protruding above the runway surface, the anchors in the area of mat movement were relocated approximately 1 ft and redriven. The anchor holes were observed to contain water due either from rainfall or the high water table.

View looking north at sta 5+00 showing skid marks in touchdown area

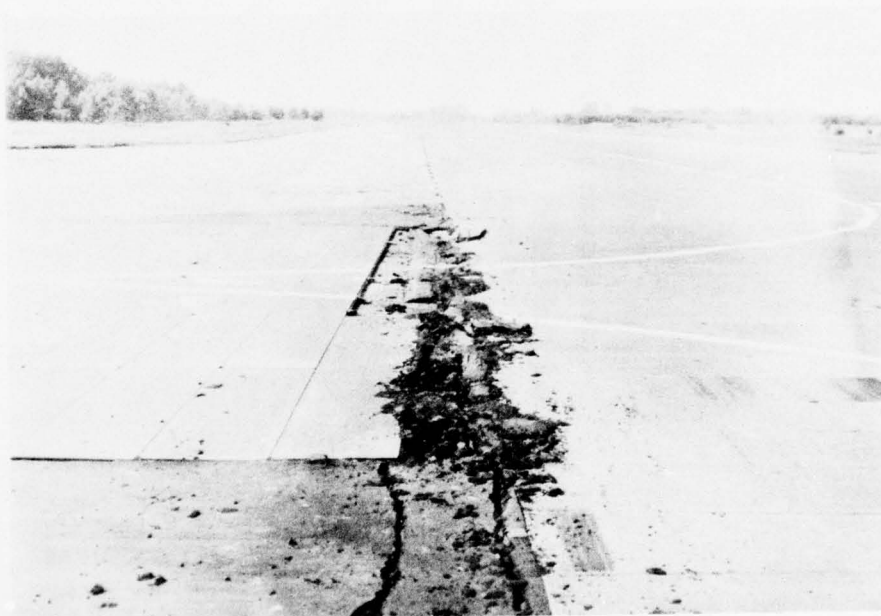
6. Prior to traffic there was a 23-in. gap at position 5 (Incl 1) which was filled with asphalt. As landings progressed the gap closed and after 250 operations the connecting taxiway mat began to ride up onto the asphalt filler. A run of the connecting taxiway mat was removed and the edge of the mat was anchored. At the end of the exercise, a 14-in. void area was noted between the connecting taxiway mat and the asphalt filler. One anchor plate was broken off and laying in the void area and numerous chunks of loose asphalt were noticed at position 5 (Incl 2b).

- b. Void area and loose asphalt at the junction of the connecting taxiway loop and the runway

locations to prevent a potential hazard to aircraft since deteriorated asphalt could be ingested into the engines or struck by the propeller blades of the C-130 aircraft.

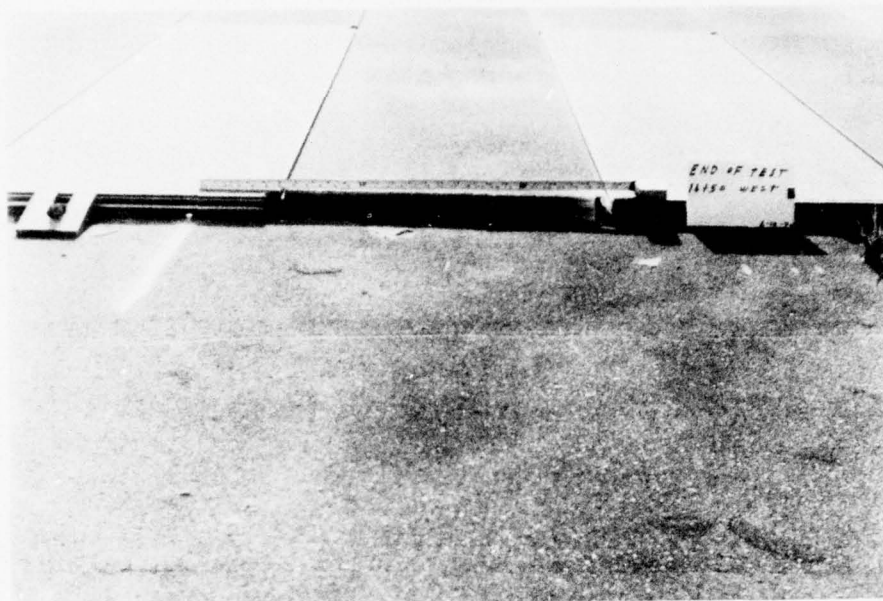
a. 30-in. mat movement on the west side of the airfield at sta 16+50

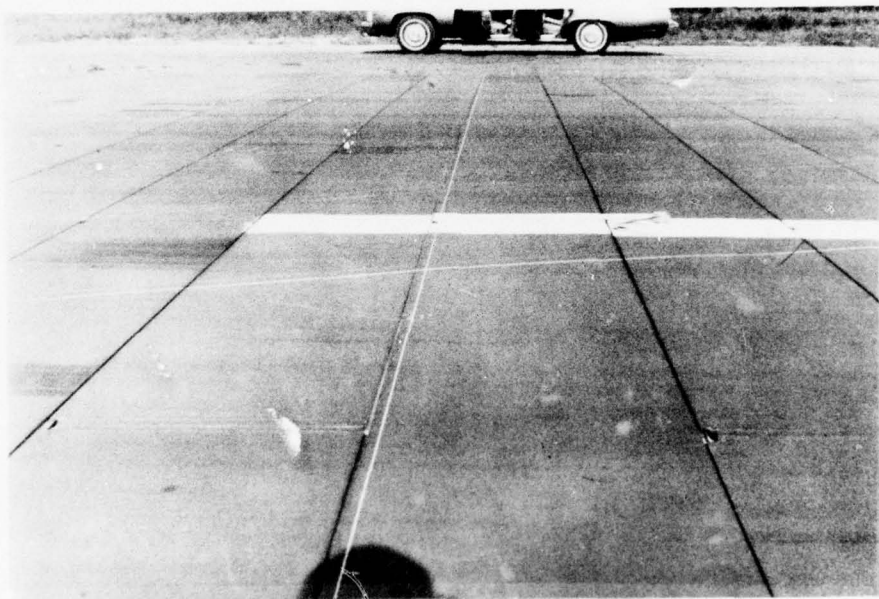
b. Bow line measurement of 1-1/8 in. at sta 16+50

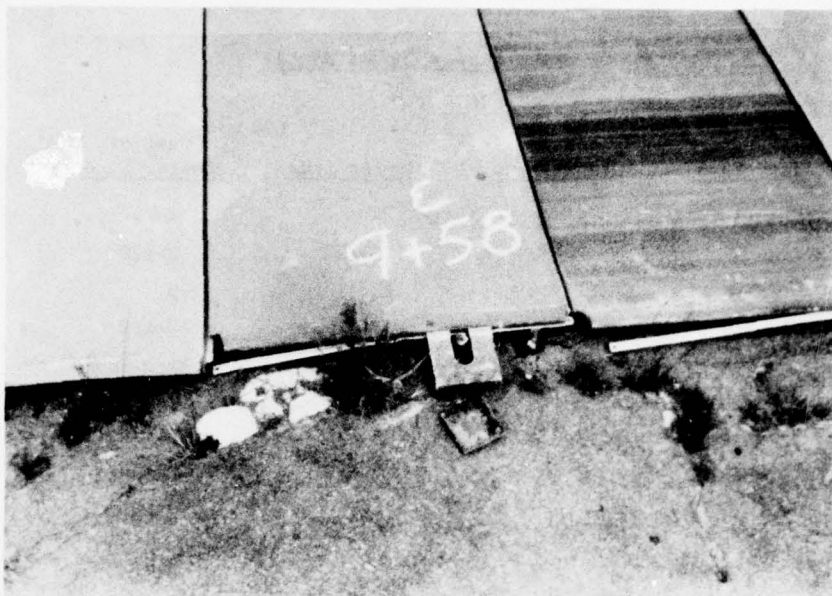
a. Failed anchor head

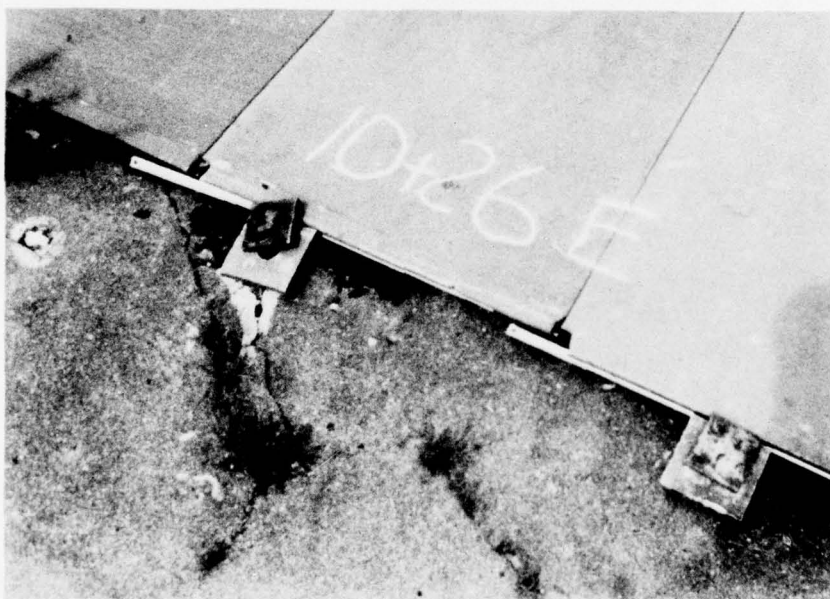
b. Anchor sheared asphalt

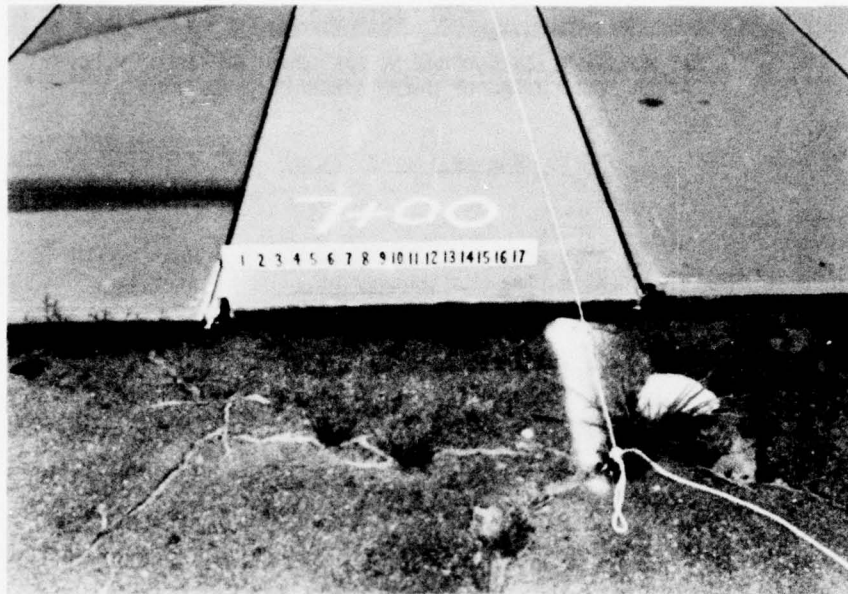
a. Mat moved 20 in. along east edge

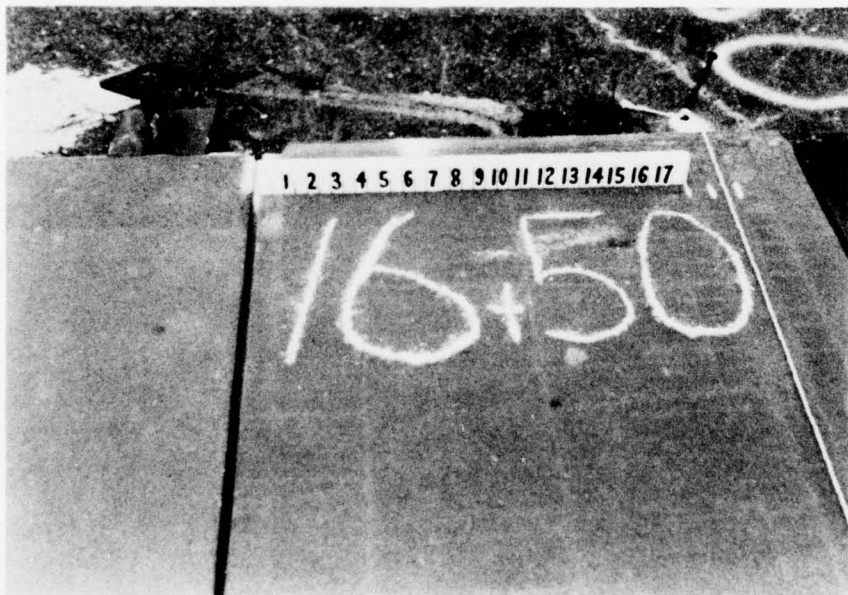
b. Mat moved 19-3/4 in. along west edge
Runway moved south (left) after 300 sorties

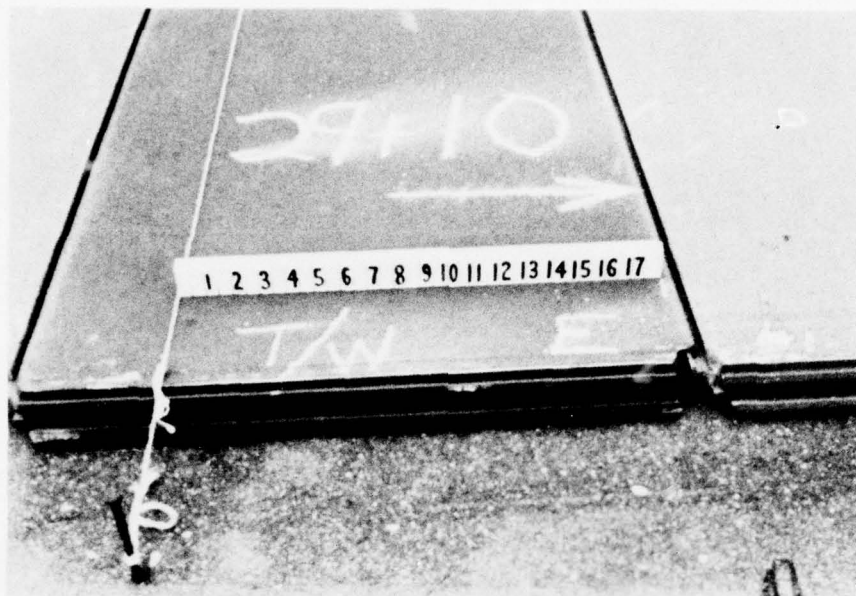
a. East edge of taxiway moved north 18-3/4 in. (right) after 300 sorties

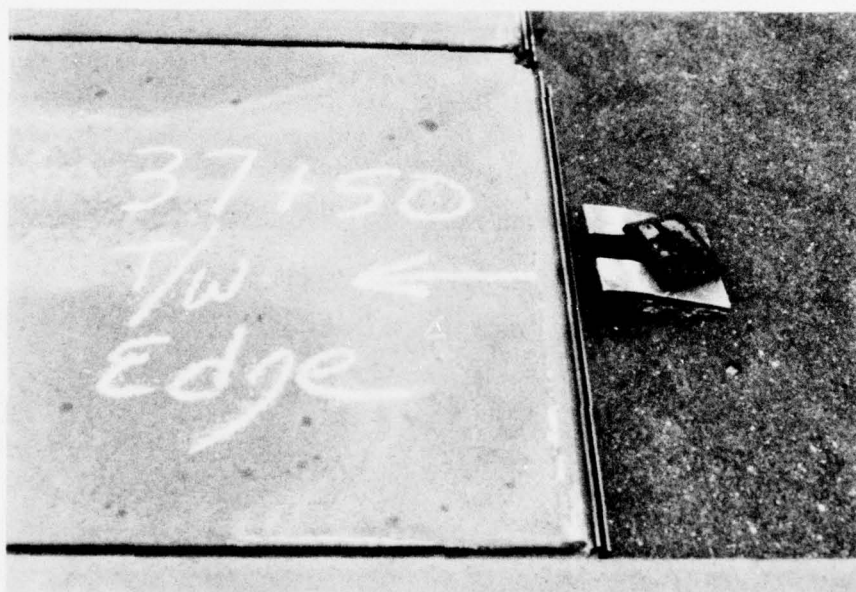
b. Radius mat shifted west away from anchor
Taxiway shifting at 300 sorties

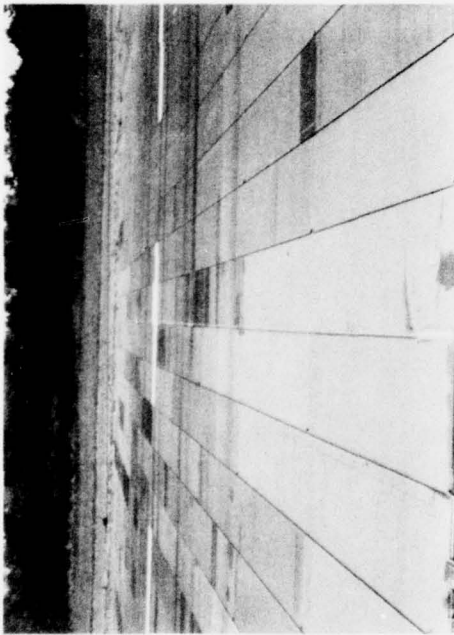
Photo 5. Bow in mat at Sta 10+00

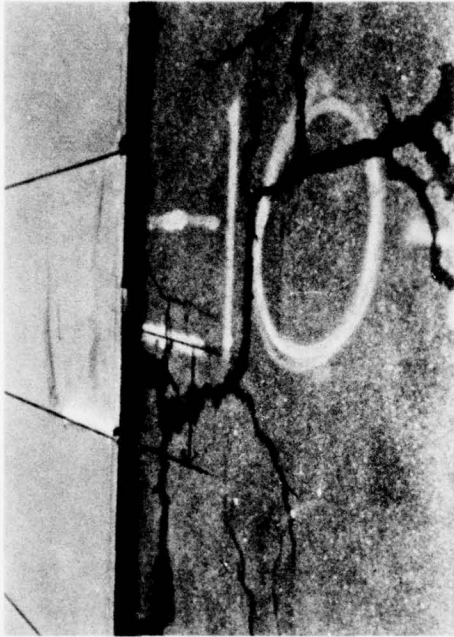
Photo 6. Mat movement at east edge of runway,
Sta 10+00

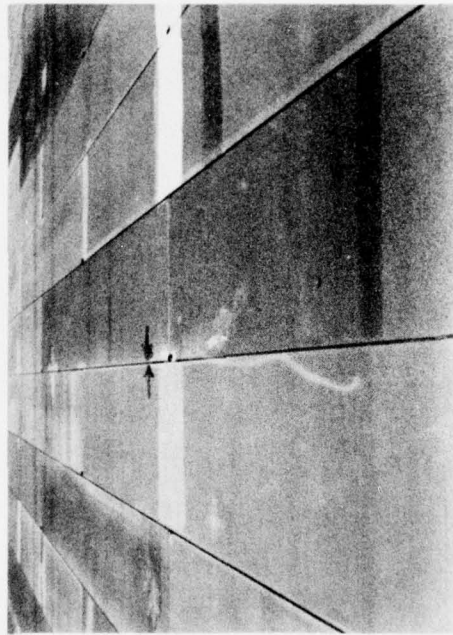
Photo 7. Slack removed in mat joints in runway at
the completion of operations

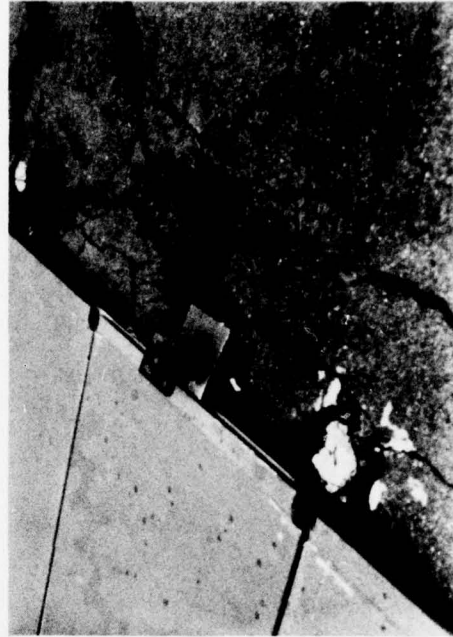
Photo 8. Loose anchor at east edge of runway in
maximum braking area

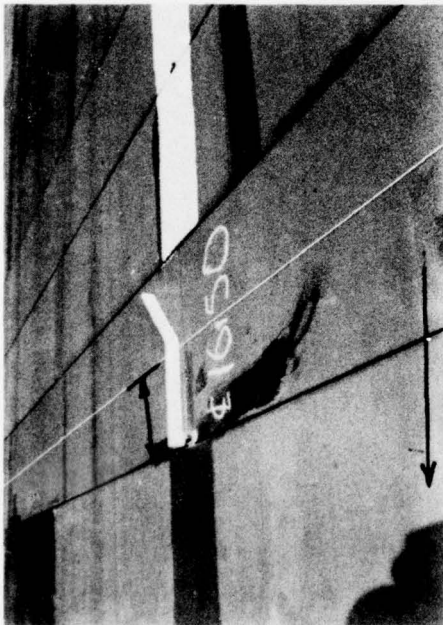
Photo 9. Mat movement at center line of runway,
Sta 16+50

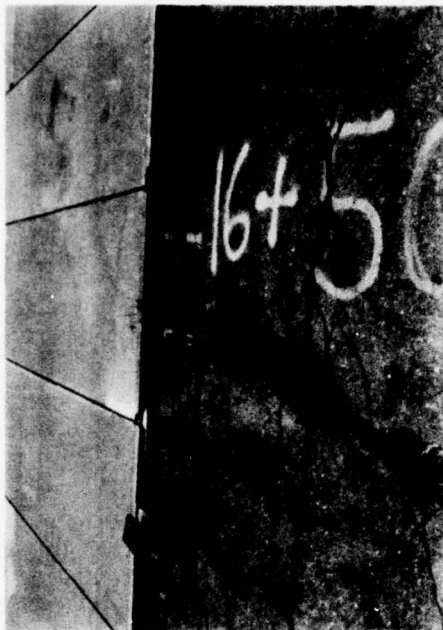
Photo 10. Mat movement, east edge of runway,
Sta 16+50

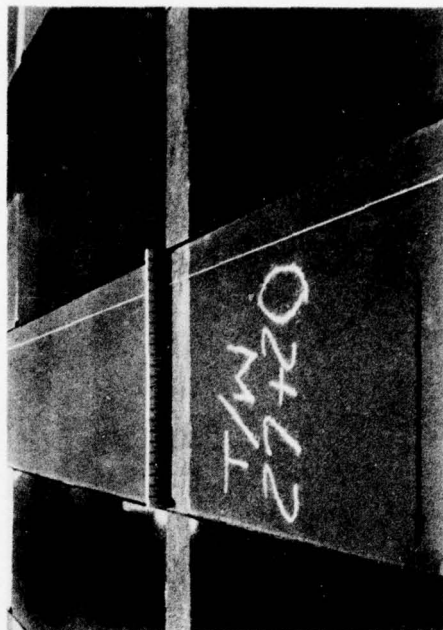
Photo 12. Mat movement at center line of parallel
taxiway at south end of runway
